Corrosion on Hastelloy X Caused by CaCl_2

Obie Gillispie
Wolfgang Dworzak
Leonardo Trujillo

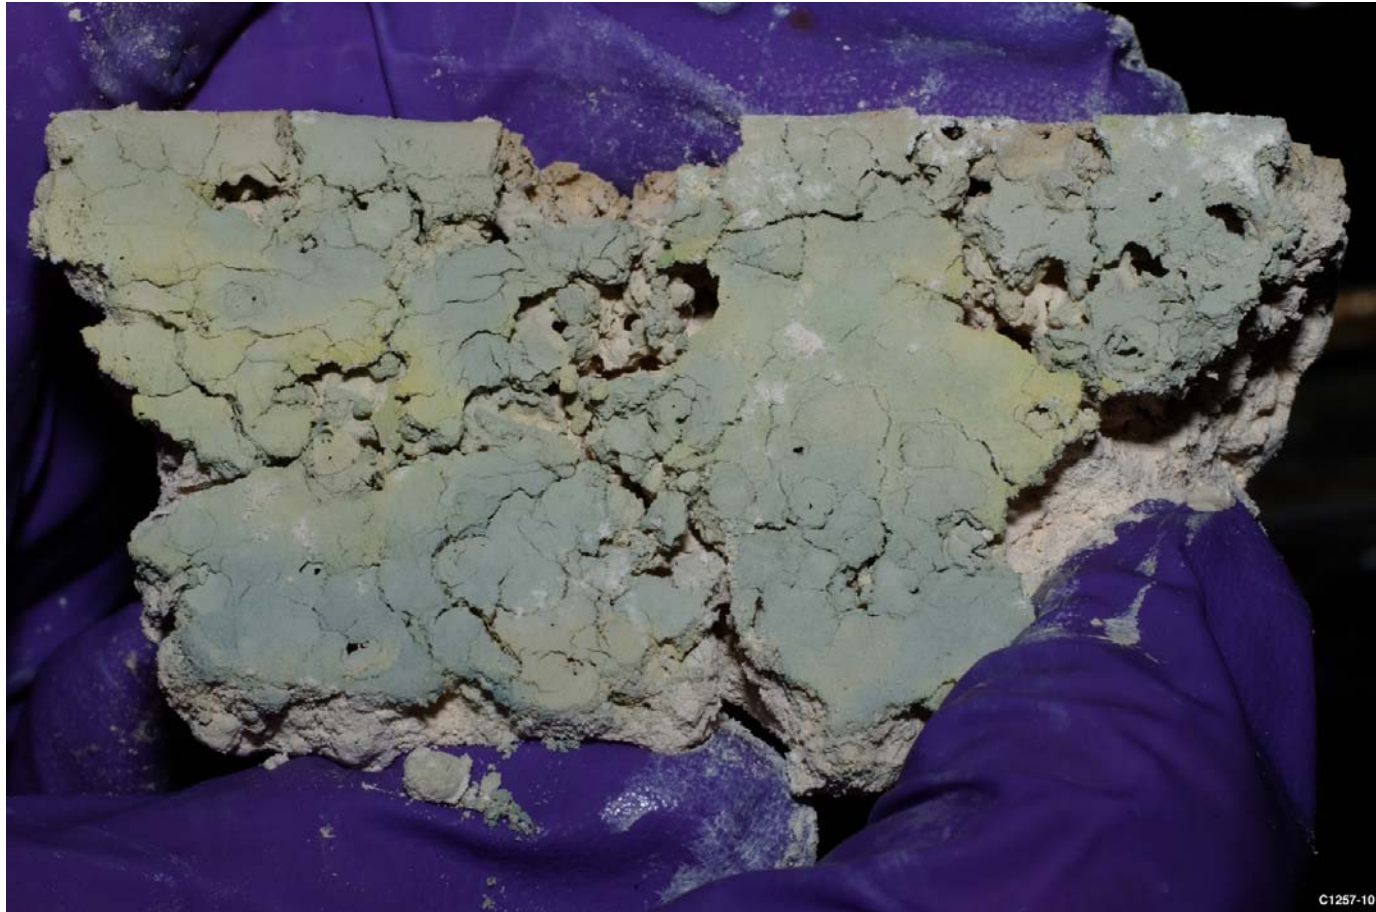
Nickel Chloride

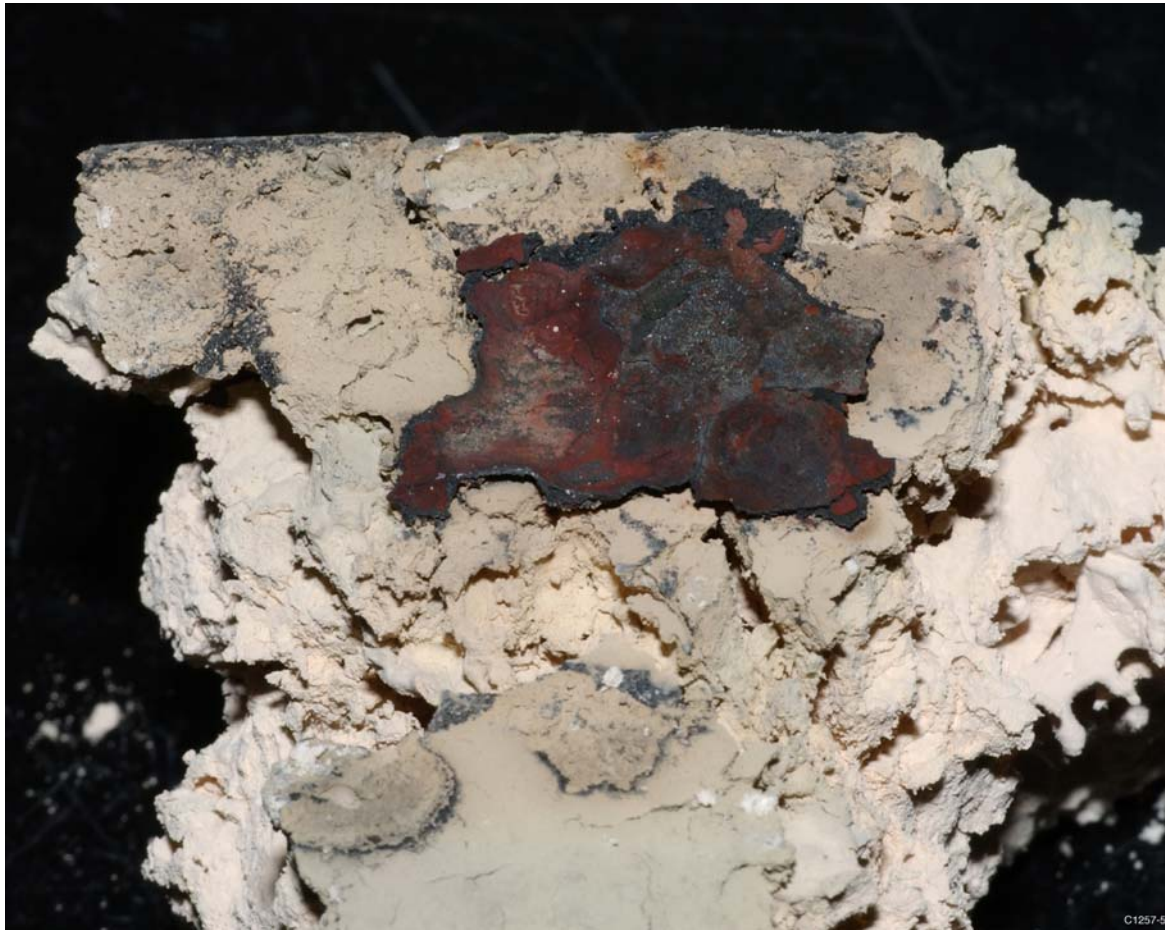
Piece of Boat on Material

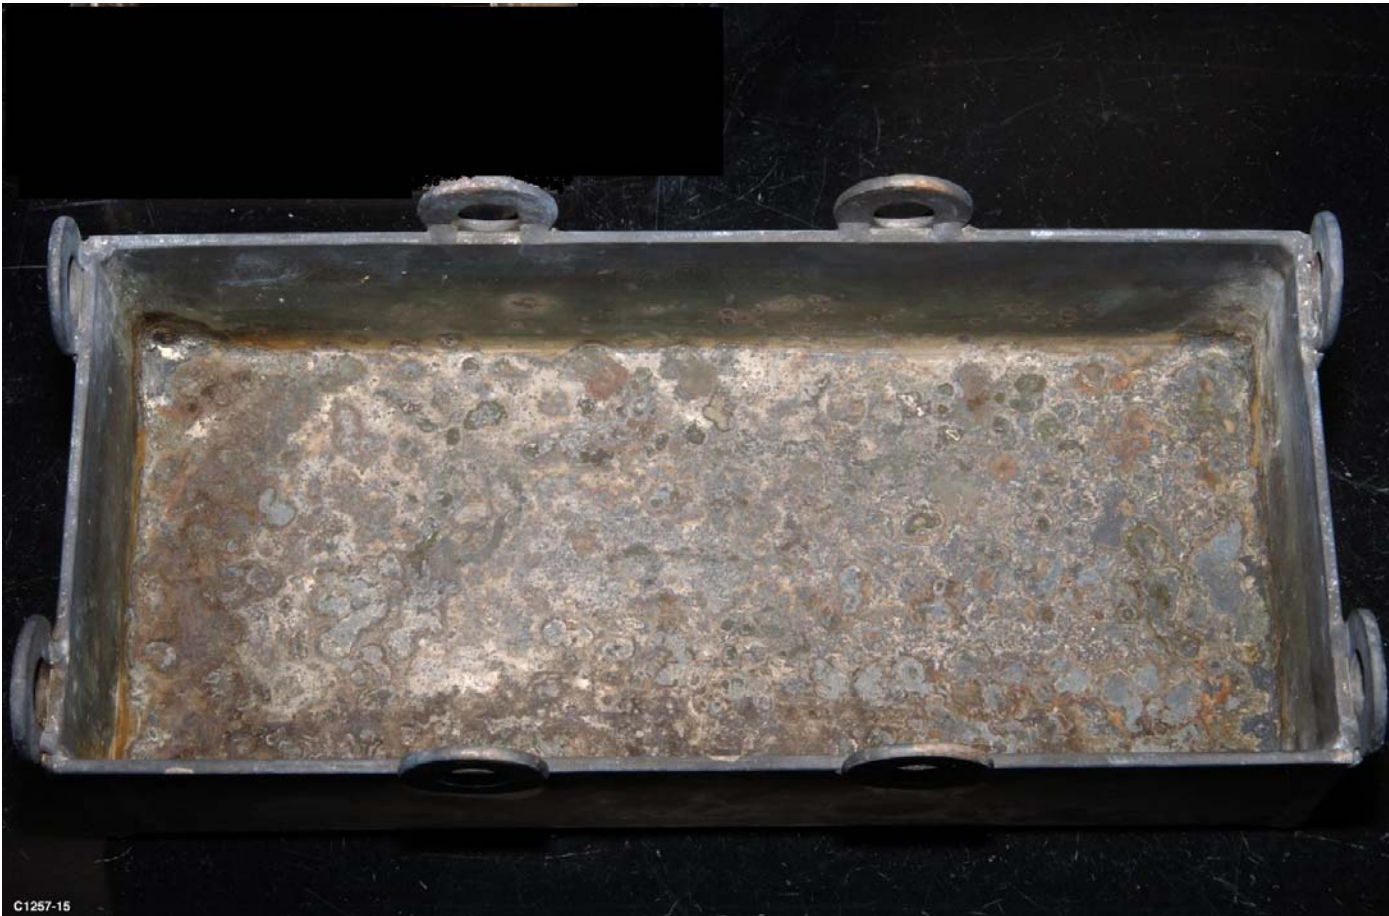
Corrosion After 1st Run with CaCl_2

- Nickel Chloride formed during calcination could cause corrosion in the 3013 can.
- Nickel Chloride is hygroscopic and can lead to additional moisture adsorption after calcination.
- Inconel has a higher nickel content than hastelloy and may experience more severe corrosion.
- Corrosion on the outside of the boat could increase the rate at which a boat would fail.

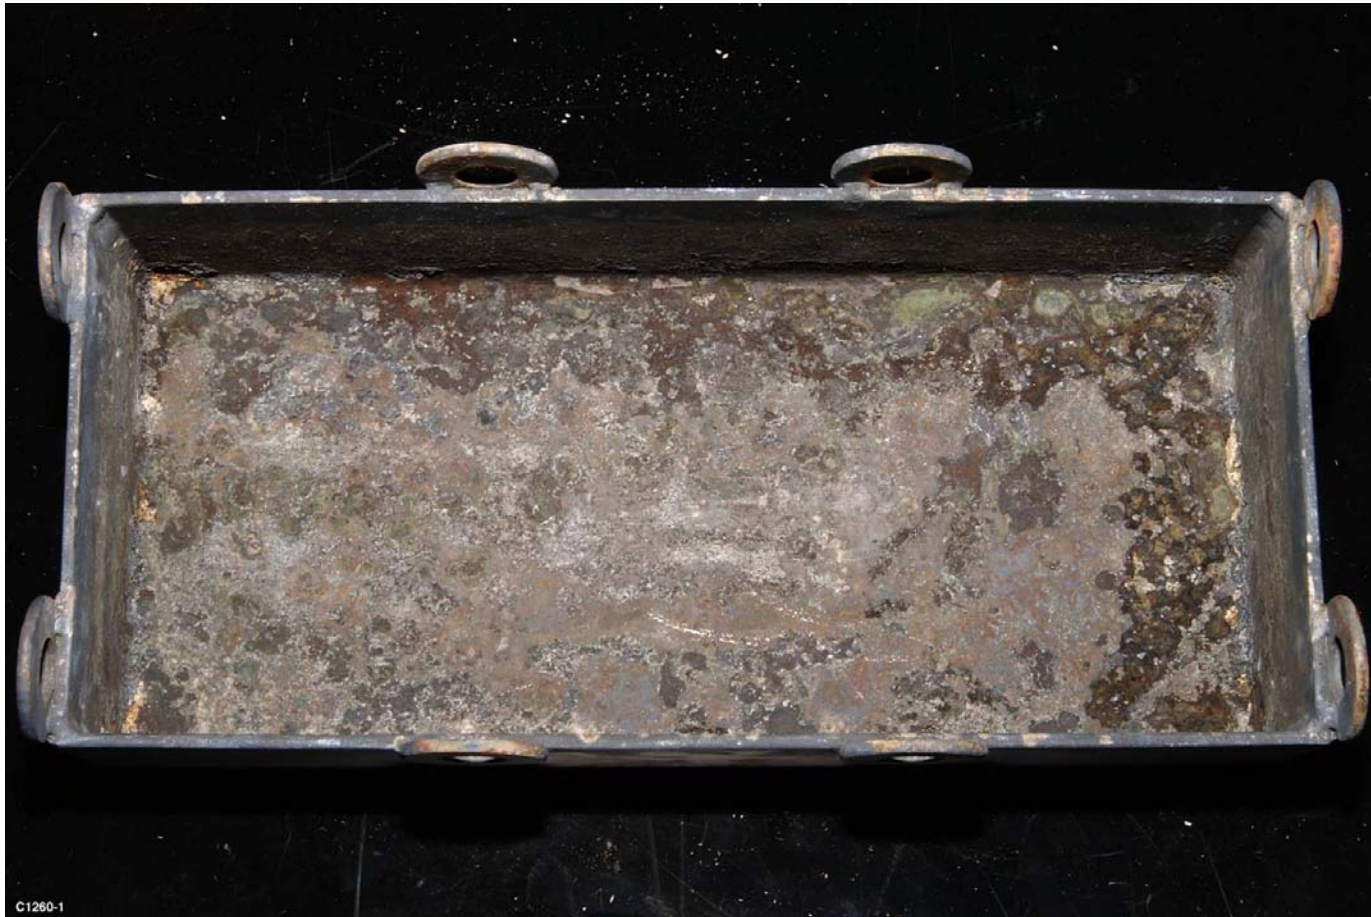
C1260-1

Corrosion After 2nd Run with CaCl_2

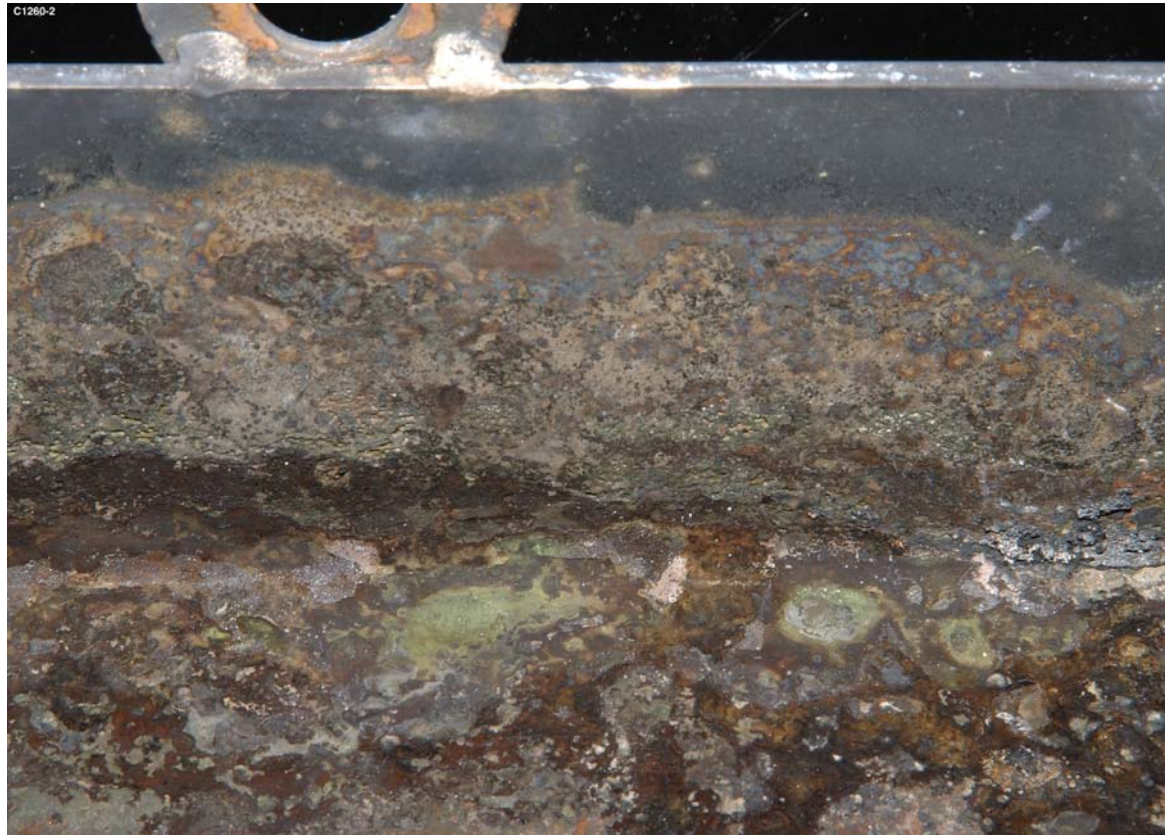
Corrosion After 2nd Run with CaCl_2

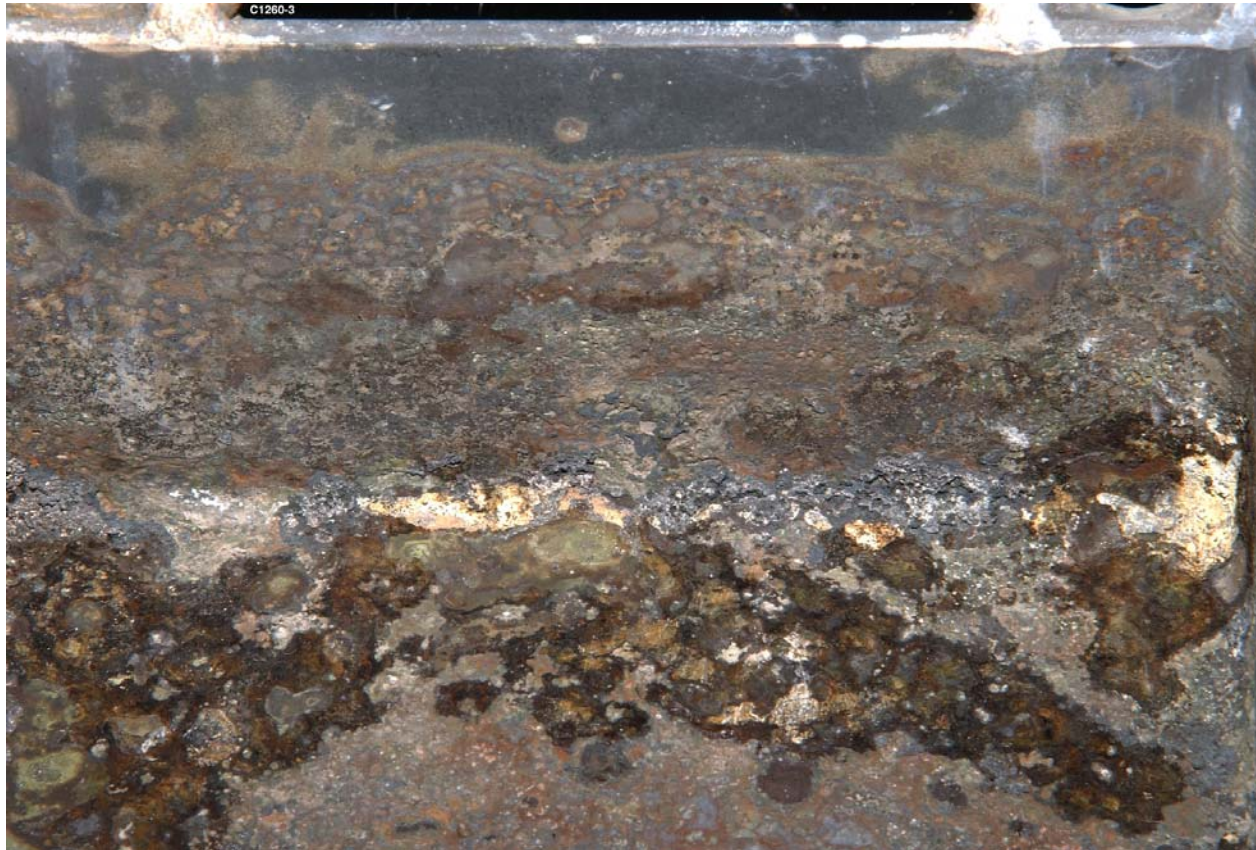
Corrosion After 2nd Run with CaCl_2

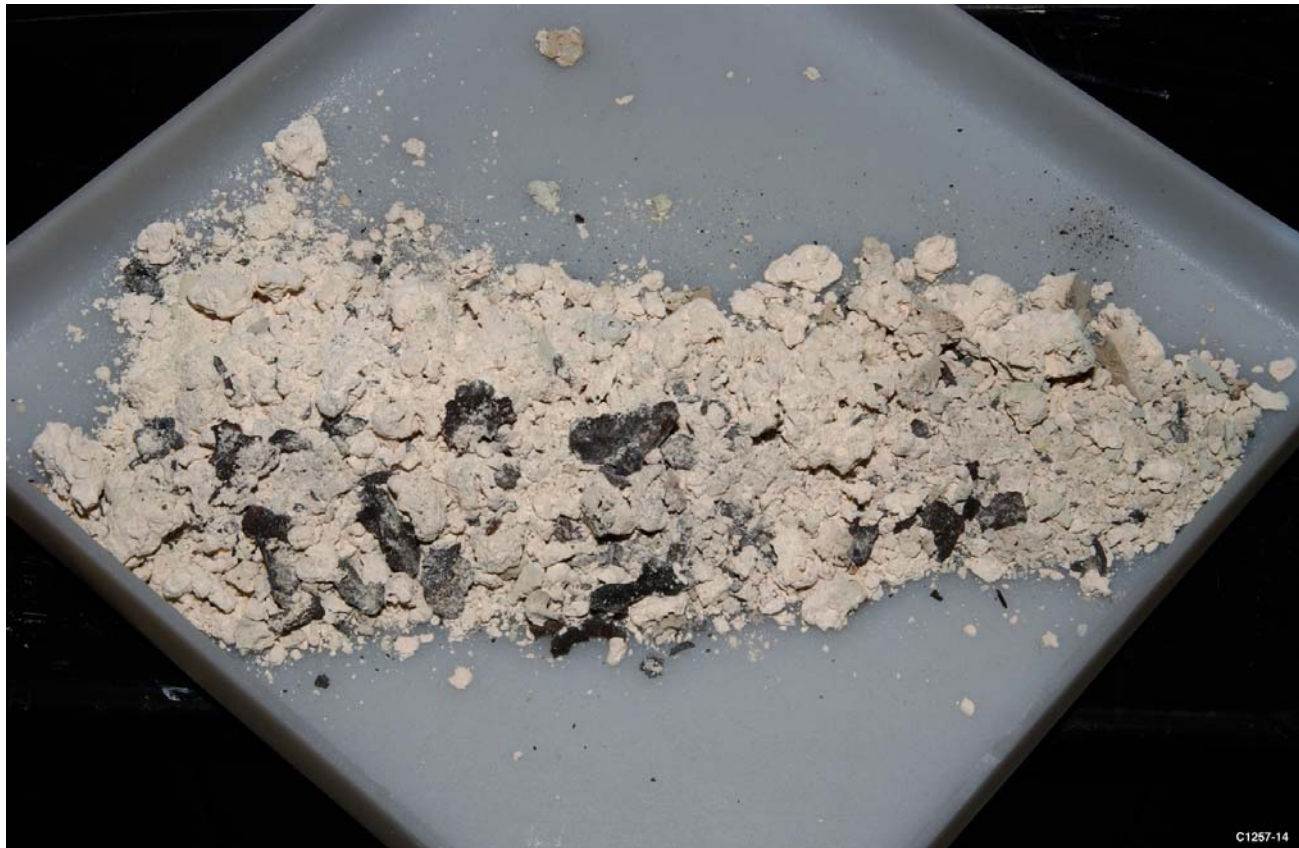
C1257-14

Boat Contents After 1st Run
